A STUDY OF CHOWHALI UPAZILLA AND ITS EFFECTS DUE TO RIVER EROSION

June - 2015

URBAN DEVELOPMENT DIRECTORATE (UDD)

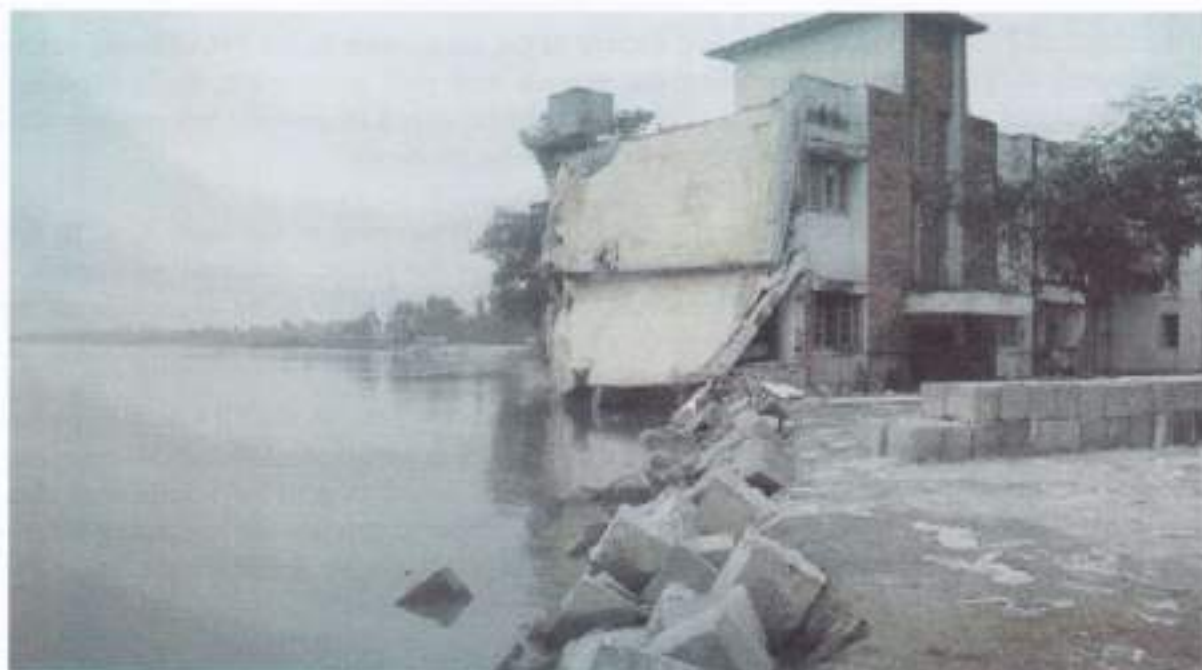
Picture-1. Chowhali Upazilla Officer's Quarter is collapsing and going under water due to river erosion.

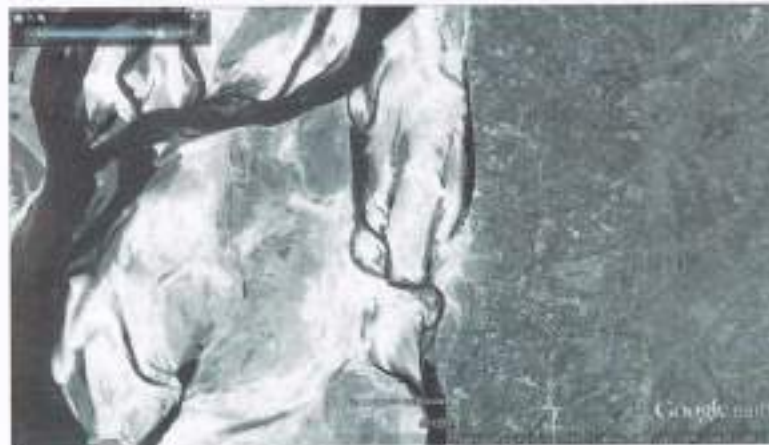
Image - 2. From google earth of the year 2008

Images from Google earth of the river Jamuna in the vicinity of Chowhali upazilla of the year 2008, 2011, 2012 and 2013 have been shown below. From these it is observed that previously there was one channel of Jamuna near the Chowhali upazilla parishad and later on it bifurcated in two sub channels and the sub channel created near the upazilla grew stronger in the last three years and hit the upazilla campus. Consequently a huge land area including the upazilla parishad bhaban, upazilla health complex bhaban and thana bhaban collapsed and went under water.

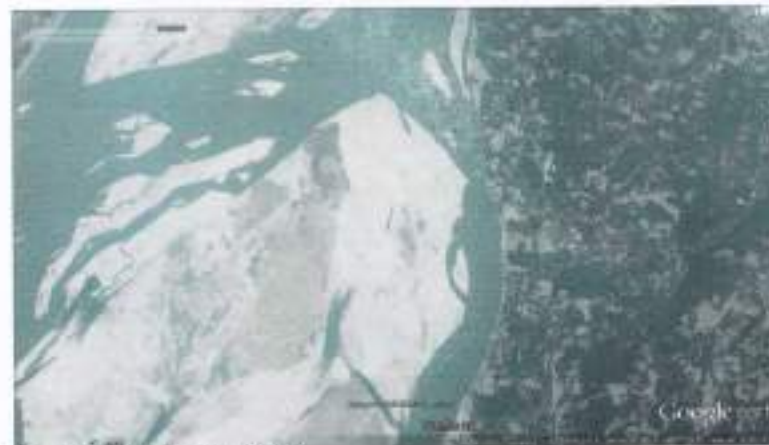
Image- 3. From google earth of the year 2008

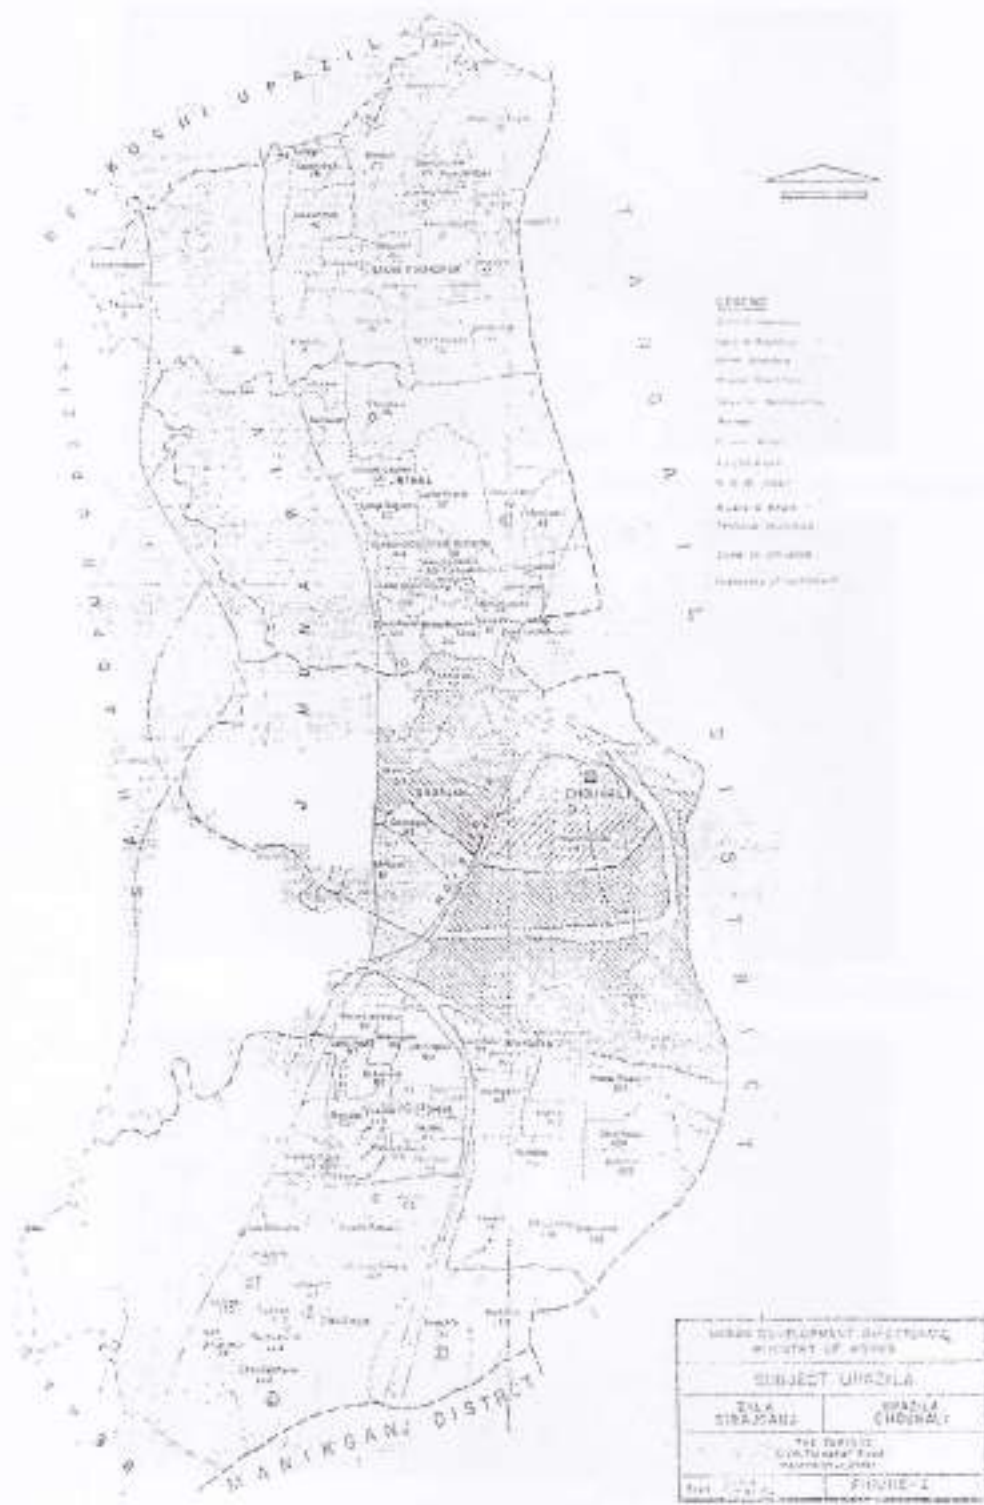
In the map it is seen that large portion of about 1/3rd portion of the total mouza map of the upazilla includes water body of the mighty Jamuna. No specific data was found about the mouzas lost fully or partially by river bank erosion. In that time the river was on the western side of the upazilla along the north south direction. All the union were affected but Bagutia union was not affected or lost even a little.

Map-2. Showing the newly formed Chowhali Upazilla land use map in 1988

1st stage of land loss due to river bank erosion: Map showing below is the Chowhali Upazilla land use plan map of the master plan of UDD completed in the year of '1988.

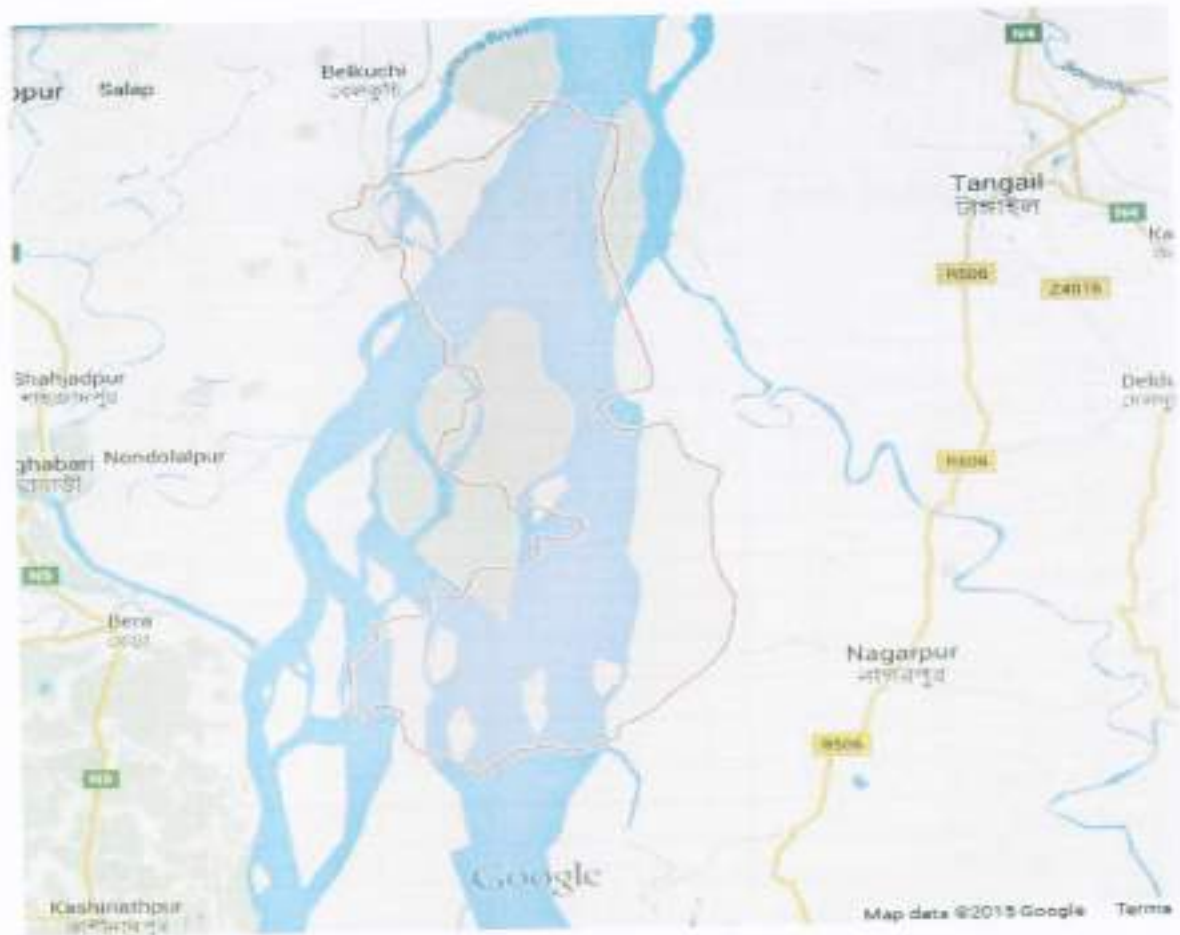
Below is shown a recent map collected from the net of Google earth . In this map the Chowhali upazilla boundary has been shown. Observing the map it is found that only a small portions of land in the Khaskaulia union, Khaspuuria union, Bagutia union and Sadia Chadpur union are still remaining out of the riverbank erosion. This map shows a huge land loss of Chowhali upazilla due to river bank erosion. It seen that more or less 2/3rd of the land of Chowhali upazilla is under water and engulfed by the mighty Jamuna.

Map-4. Showing the recent map of Chowhali upazilla boundary and the river Jamuna from the net of Google earth (main land, char area, water body)

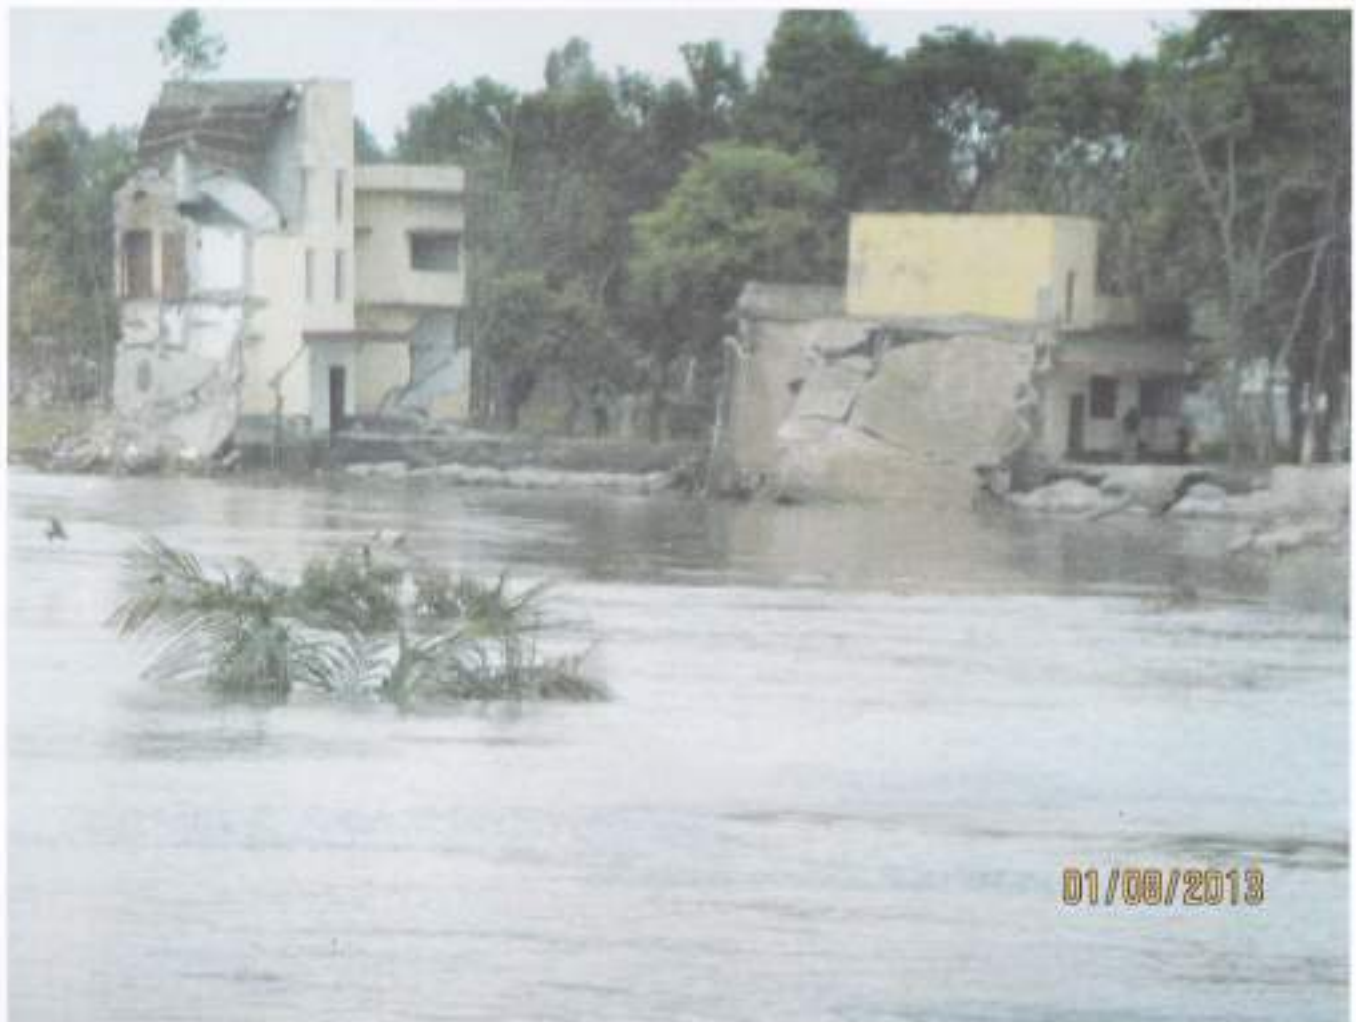
Picture-4. Showing Upazilla Parishad office buildings are going under water due to river erosion in the year-2013.

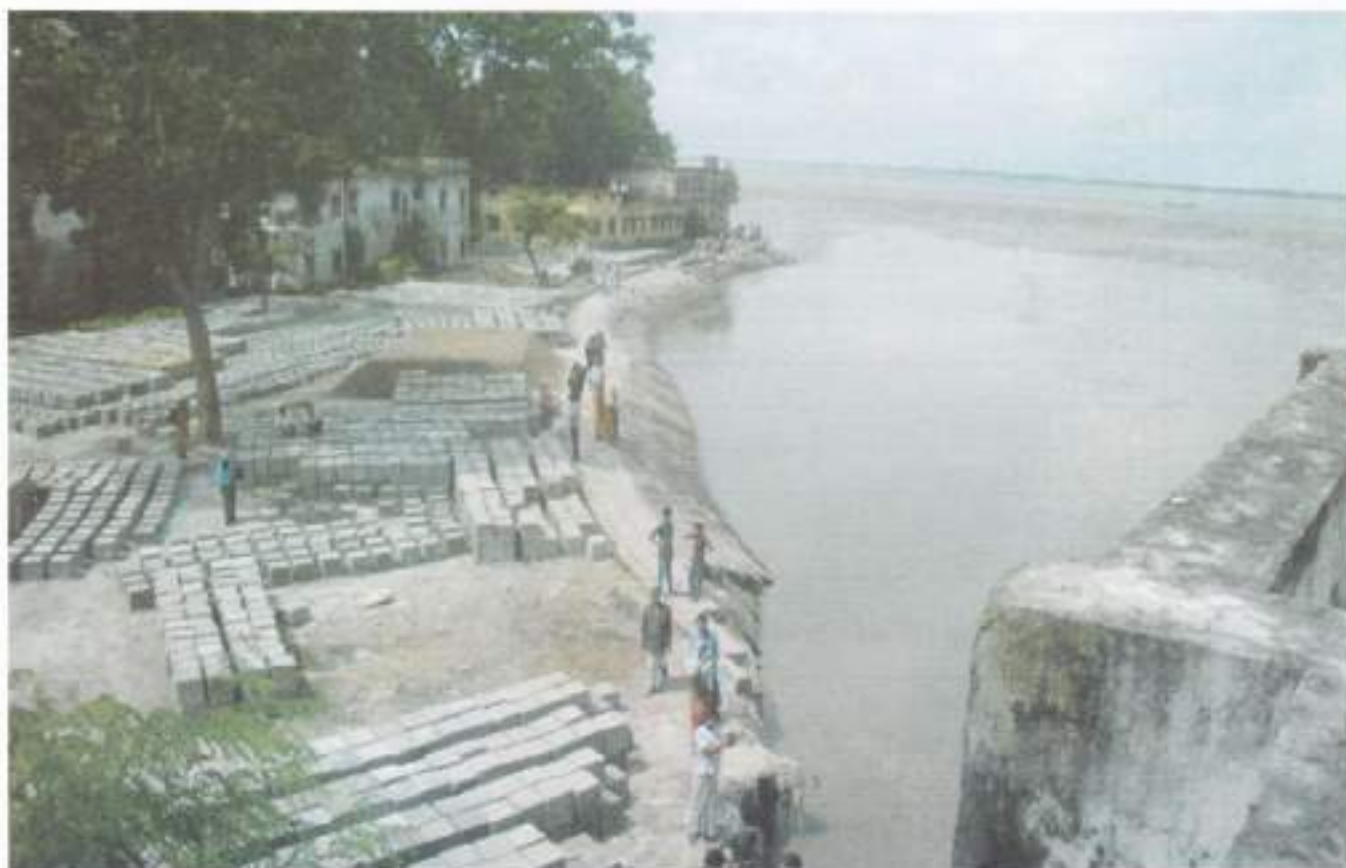
Picture-5. Upazilla Parishad campus is in a big danger due to threatening of the river in early stage of erosion.
